Manhole Inspection Summary

Manhole # S15Q__025MH

Insp Date: **4/7/08 2:56 PM**

Location Address: **913 cole st**

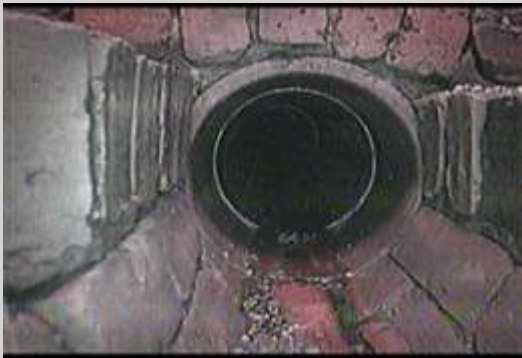
12 O'Clock Outflow

Pipe Height: **8.4** (in.) Rod and Bar (Angled)
Pipe Material: **Clay** ☐ Pipe Lined
Invert Depth: **7.39** (ft.) Flow Characteristics: **Slow**
Deposits: ☒ None ☐ Mud ☐ Sludge ☐ Debris ☐ Grease
Silt Depth: **0** (in.) Deposits Extent:
Infiltration: **None** Pipe Seal Cond: **Sound**

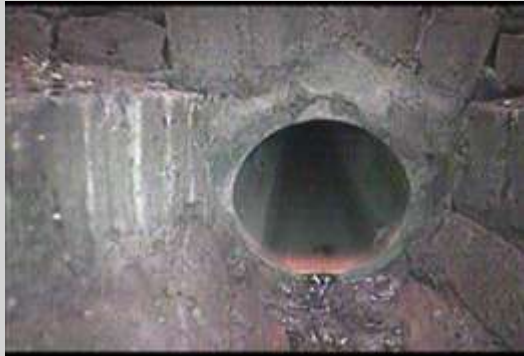
9 O'Clock Inflow

Pipe Height: **6** (in.) Rod and Bar (Angled)

Pipe Material: **Clay** ☐ Pipe Lined

Infiltration: **None**
